LONG TERM PERFORMANCE OF
THREE BRIDGES ON PERMAFROST

FINAL REPORT

Dean Baldassari
Research Engineer

September 1985

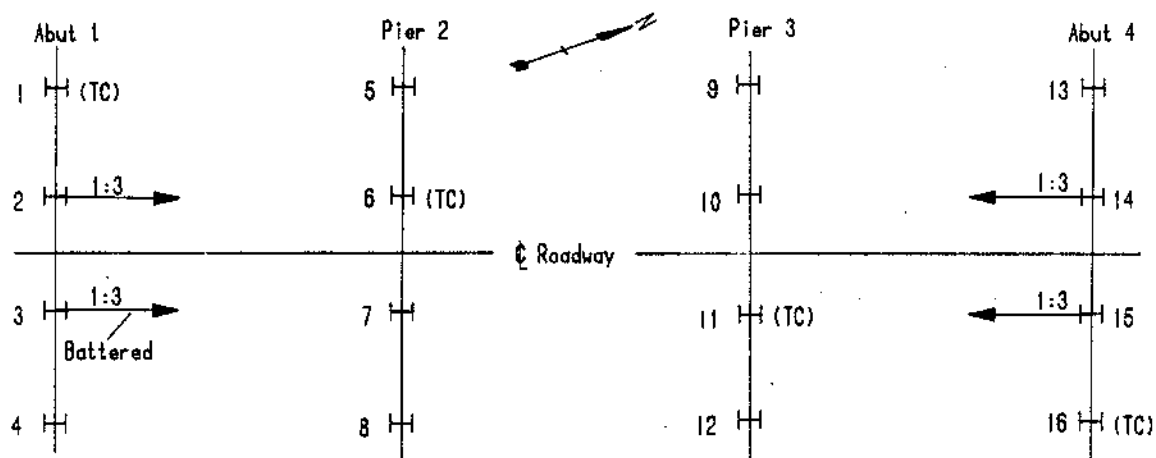
FIGURE 2: GOLDSTREAM CREEK PILE LOCATIONS (TC DENOTES THERMOCOUPLE LOCATION)

Pile driving began at the Goldstream Creek Bridge in May of 1965. Each abutment and pier is supported by four 10 BP 57 piles at locations as shown by Figure 2. The two interior piles in each abutment were battered towards the stream (1H:3V) in order to counter the thrust of the abutment fill. All abutment piles were driven to an elevation of 520 ft (158.5 m) [approximately 42 ft (12.8 m) below the approach fill]. The two piers, each
